# Manhole Inspection Summary

Manhole # S04CC2017MH

Insp Date: **9/26/06 1:32 PM**

**Location** Address: **6708 CROSS COUNTRY BLVD** Cross Street: **LABYRINTH RD**

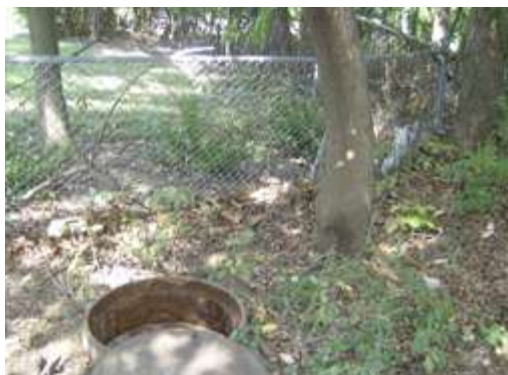
Location View

Comments **BEHIND PARKING LOT NEAR FENCE. The O12 pipe picture shows Channel root intrusion, debris and grease deposits.**

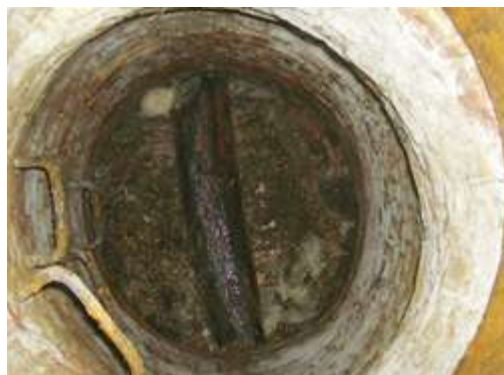
Top View

Adjustment and Corbel infiltration.  
Corroded steps. Evidence of surcharge -  
Bench debris.

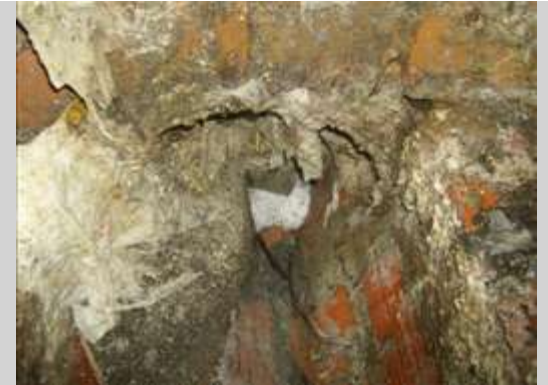
### 8 in. Circular Gravity Sewer Pipe Out @ 12 O'Clock

Deposits: ☐ None ☐ Mud ☐ Sludge ☒ Debris ☒ Grease

Silt Depth: **6** (in.) Deposits Extent: **Heavy**

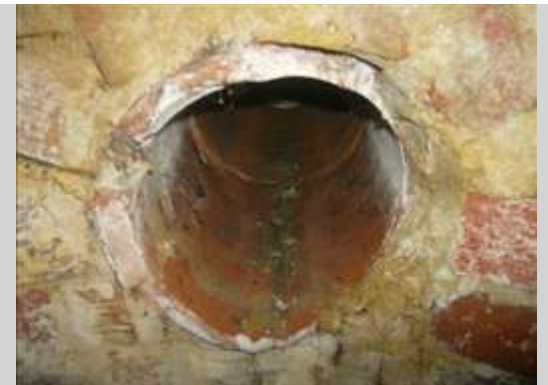
### 8 in. Circular Gravity Sewer Pipe In @ 6 O'Clock

Infiltration: **None** Pipe Seal Cond: **Unknown**

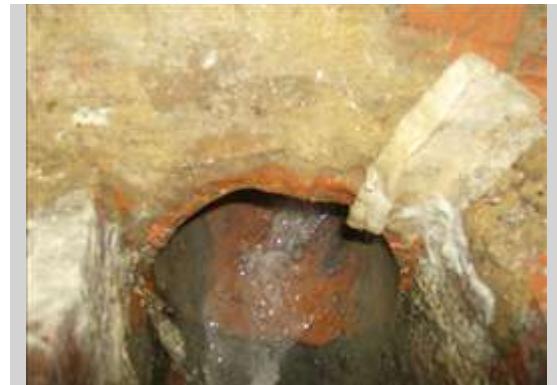
### Drop In @ 6 O'Clock

Drop: **Outside** Rod and Bar

Drop Condition: **Open**
